Project IND1705 Ultrafast Microprobes

Deliverable D7

Good Practice Guide – In-situ wear damage measurement using fast microprobes with integrated feed-unit

Mark Gee, Timothy Kamps, John Nunn, Peter Woolliams
National Physical Laboratory

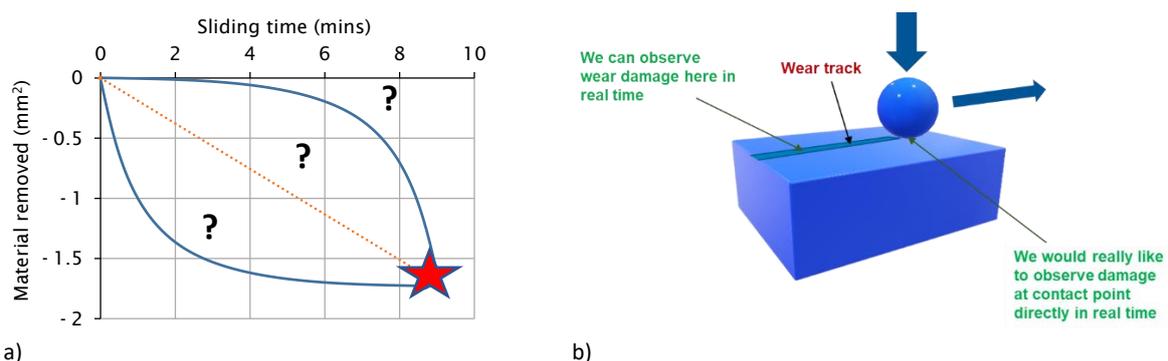
a) *Figure 1, Aspects of sliding wear testing, a) materials removal against time in wear test. The two blue and the orange paths could all be possible but cannot be determined from post-tests measurements made at end of test (red star), b) schematic showing contact between moving ball and flat in a wear test.*

Although the tribological contact itself can only be observed if one of the contacting bodies is transparent, the wear to the surface that is not in contact all of the time can be observed away from the wear contact (Figure 1b).

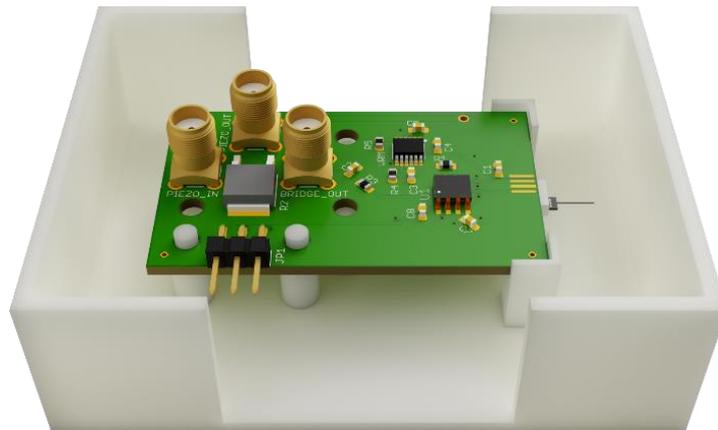
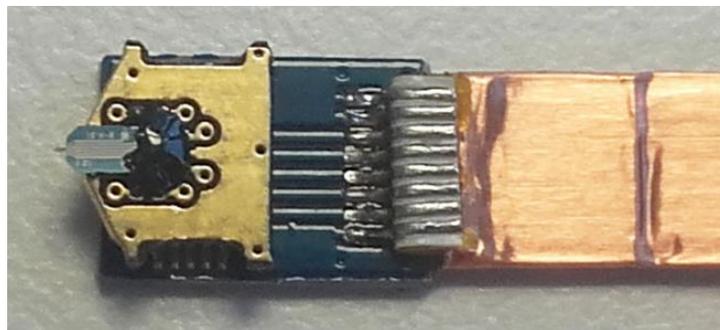
Figure 2, microprobes used, a) TUBS / PTB microprobe mounted on pcb in carrier case. Note cantilever projecting from edge of pcb, b) SCI Sensortech microprobe

The two different microprobe systems that were used are shown in Figure 2. Most experiments were carried out with the microprobe design from Technical Universiteit of Braunschweig (TUBS) and PTB (Figure 2a). For the experiments with the NPL microtribometer, a second microprobe design was used obtained from SCI Sensortech (Figure 2b).

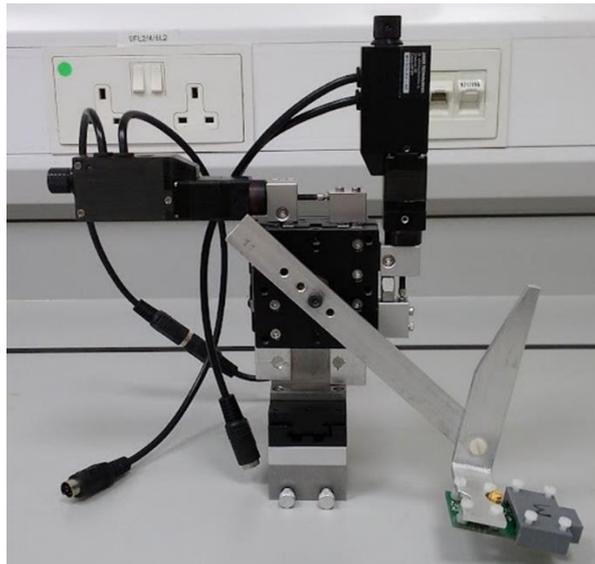
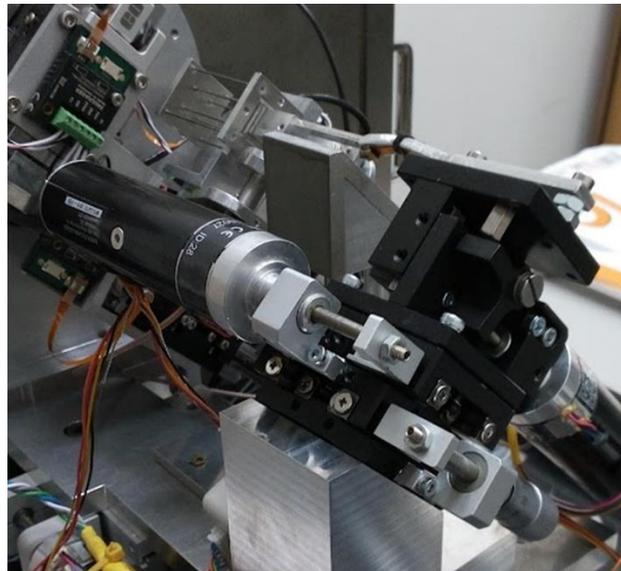
Figure 3, Actuator systems for microprobes, a) TUBS/PTB microprobe, b) SCI sensortech microprobe.

The microprobe sensor systems were mounted into two different actuator systems for the two different probes (Figure 3). Figure 3a shows the TUBS / PTB microprobe mounted in a two axis actuator system that was designed to give a vertical movement of 10 mm, and a horizontal movement of 10 mm when a profilometric scan was being made. The microprobe is mounted at an angle of 15°. Figure 3b shows the arrangement for the SCI Sensortech microprobe which is functionally similar, but was designed to fit with the NPL in situ microtribometer [6].

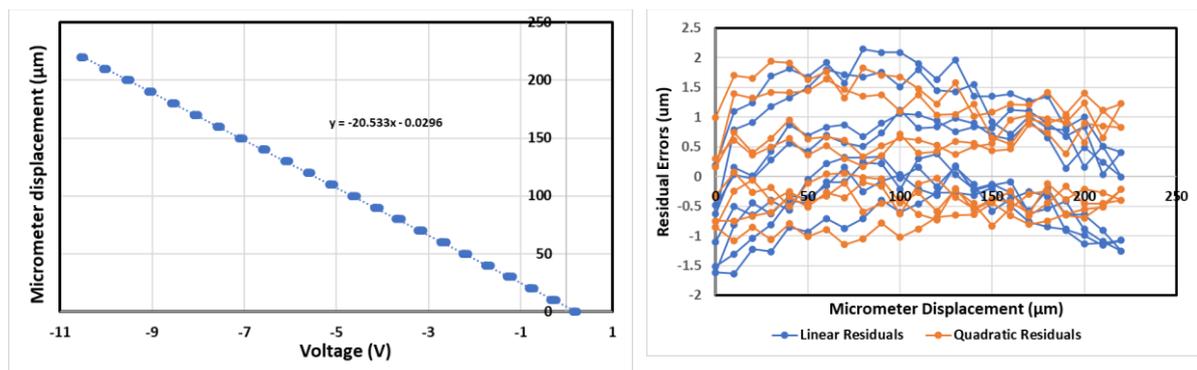
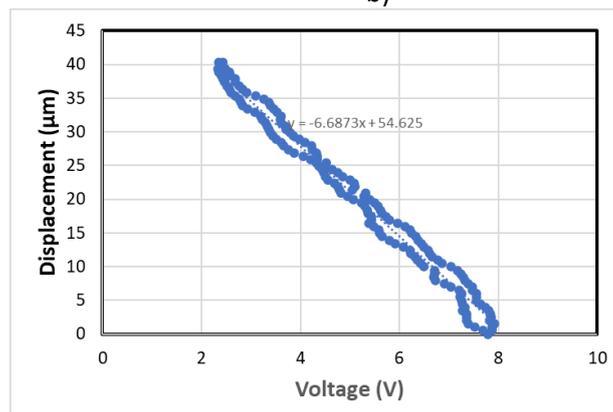
Figure 4, Calibration curves a) TUBS/PTB microprobe, b) residual plot from calibration of TUBS / PTB microprobe, c) SCIsensortech microprobe, d) residual plot from calibration of SCIsensortech microprobe.

The TUBS / PTB microprobe was calibrated against a barrel micrometer that had previously been traceably calibrated. The cantilever was inclined at 15 degrees to the horizontal and a glass microscope slide was used as the contacting surface for the stylus. A typical calibration plot is shown

in figure 4a. Repeated calibration runs were carried out and the data was fitted both linearly and quadratically. The residuals are plotted in figure 4b. It is acknowledged that the ‘noise’ in the residuals is most likely due to human error when reading the barrel micrometer (resolution of 1 μm), but the residuals of the linear fit make it clear that there is a small quadratic component in the voltage-displacement relationship of the microprobe cantilever.

The shorter length of the SCI Sensortech cantilevers makes their deflection range smaller, and hence makes them more susceptible to breaking when their small deflection range is exceeded. Since the calibration process for these shorter cantilevers is more delicate (and needed to be repeated more frequent through accidental damage), an automatic calibration routine was developed comparing the cantilever voltage output against the steps of the previously calibrated motorised actuator stage used to position it.

It is acknowledged that the yaw, pitch and roll of the positioning stage compounded by the length of the arm holding the microprobe against the sample surface produces an undesired ‘Abbe’ error in the calibration (seen in the slight waviness of the plot), but this was accepted as it mitigates the risk of breaking the short cantilevers while attempting to calibrate them manually. The plot also shows the effect of backlash as the direction of travel is reversed, but there is sufficient data to obtain a reasonable calibration constant. There is no point plotting the residuals on a separate graph as they can be seen clearly already. These residuals are entirely attributable to the ‘Abbe’ error

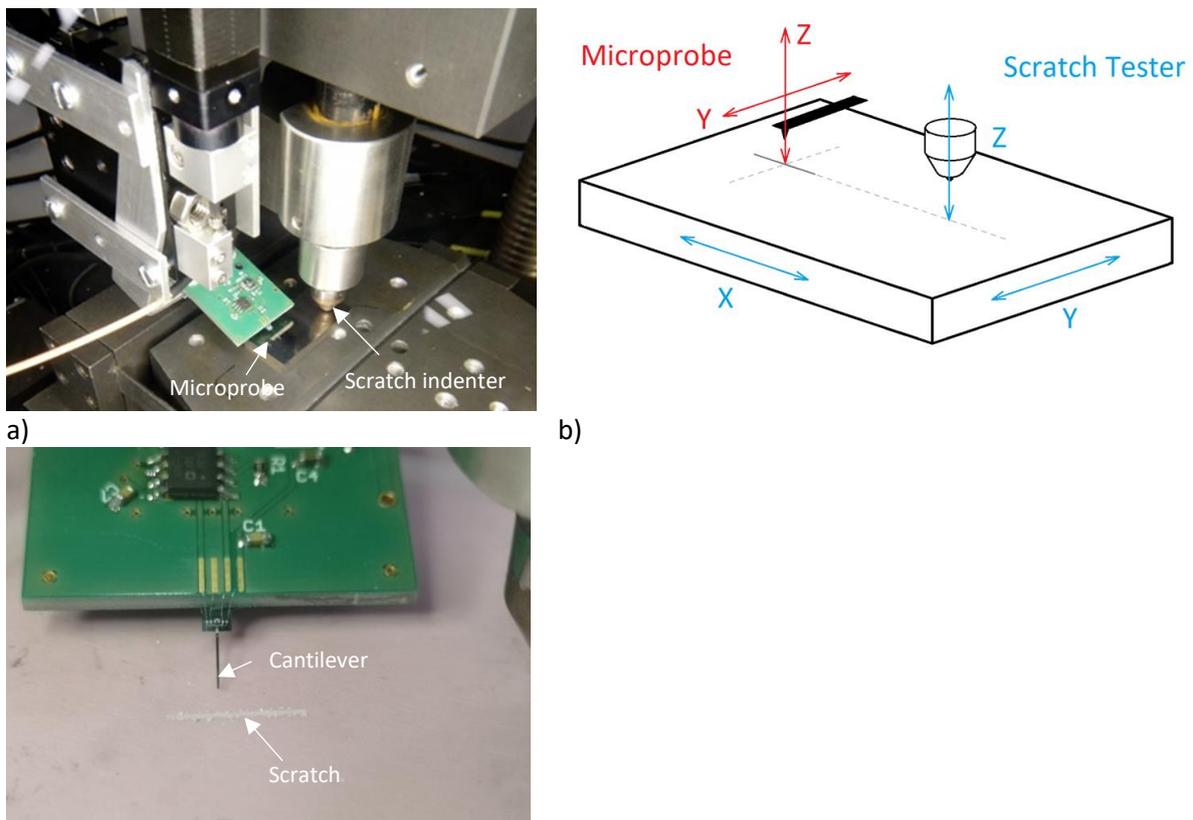
c) *Figure 5, Microtribometer with scratch test system, a) test setup, b) schematic of testing arrangement, c) detail of microprobe and scratch to be measured*

The arrangement of the microprobe in the scratch testing system is shown in Figure 5a. In the test, the scratch indenter is lowered onto the sample (in this case a ground 95 % alumina ceramic) and the sample traversed under the scratch indenter (Figure 5b). After the scratch has been carried out, the scratch indenter is removed from the surface and the sample is moved to the position where the microprobe scans a profile across the scratch. This cycle is repeated until the necessary number of repeats has been carried out. Figure 5c shows a higher magnification view of the cantilever of the microprobe close to the scratch on the pink sample.

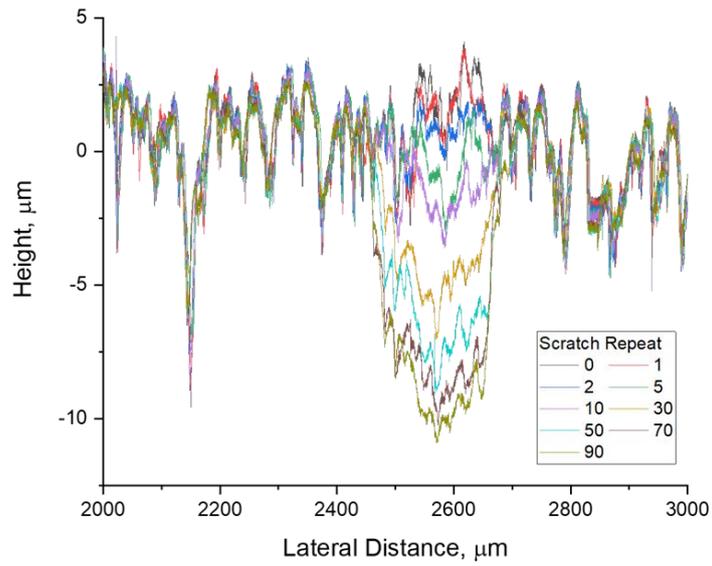
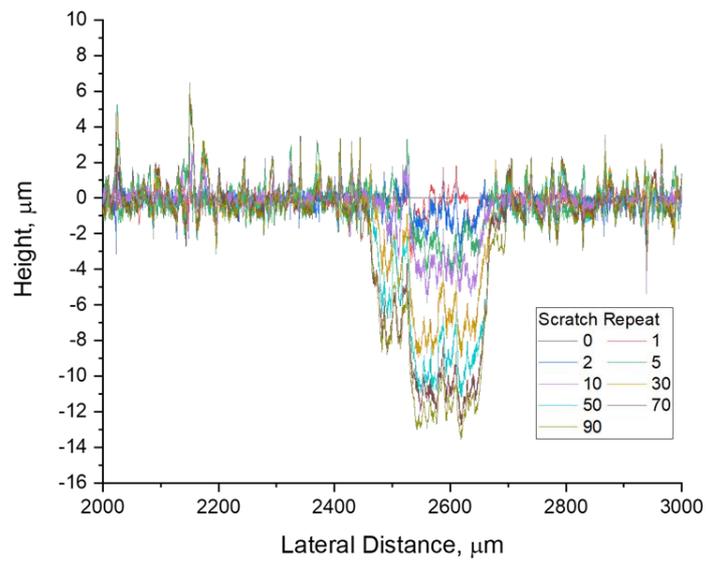
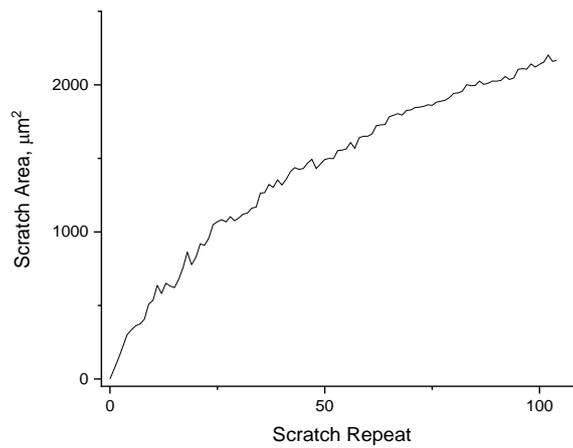
Figure 6, Results from measurements with scratch testing system, a) raw profiles taken across scratch at different number of scratch repeats, b) profiles across scratch referenced to first profile, c) variation of calculated scratch area with scratch repeat.

Figure 6 shows quantitative results from the microprobe profile measurements. Figure 6a shows the raw profiles taken across the scratch. It should be noted that the surface of the alumina test sample was quite rough, as shown by the profile over the surface away from the scratch itself. The profiles were registered with one another by correlating the profiles in these regions away from the scratch. The progressive increase in the depth of the scratch can be seen clearly.

The profiles over the sample surface away from the scratch vary with the number of repeats. This is because there is an uncertainty in positioning of the microprobe for these scans which means that the different profiles are taken at slightly different positions.

Figure 6b shows profiles across the scratch where the zero repeat scratch profile (the profile of the surface before any scratches) was used as a reference profile and was subtracted from the other profiles. There is some remnant variation in the profiles outside the scratched area due to the uncertainty in the position of the microprobe scan from one profile to another. The profiles across the scratch shown in Figure 6b were also zeroed by setting the average height of the profile away from the scratch to zero.

The area of the scratch can be found by integrating the area of the profiles. Figure 6c shows how the calculated area of the scratch increases with the number of scratch repeats. This provides good quantitative information on the degree of damage and its relationship to the number of scratches. This compares with the conventional method of monitoring how the damage increases with the number of scratch repeats which is to carry out a sequence of different scratches at different repeats which are individually measured after the scratching to determine the area of the scratch for a given number of repeats.

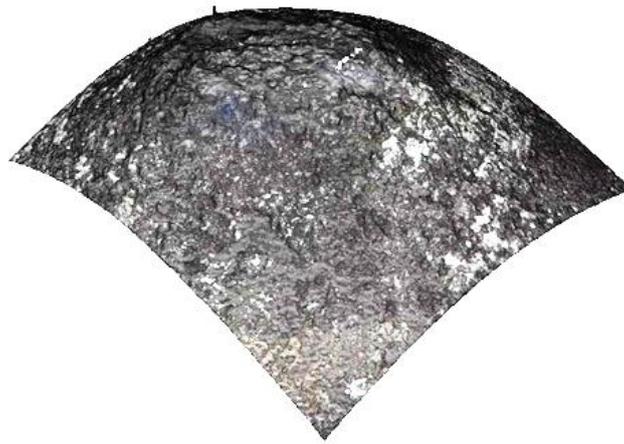
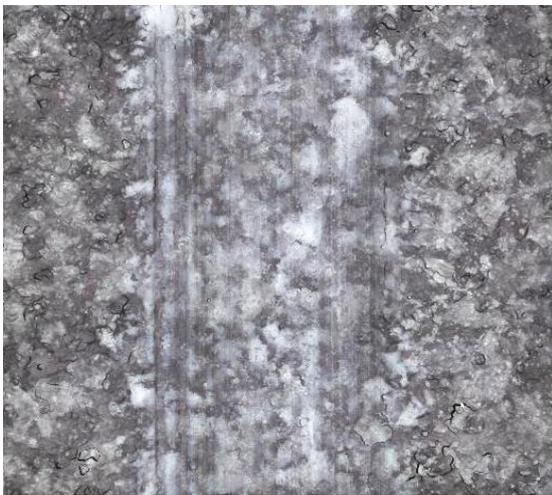
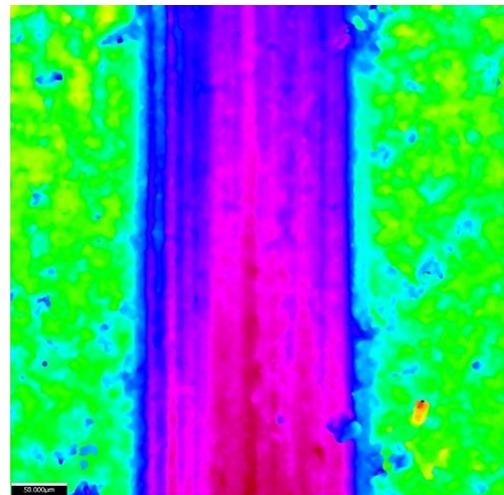
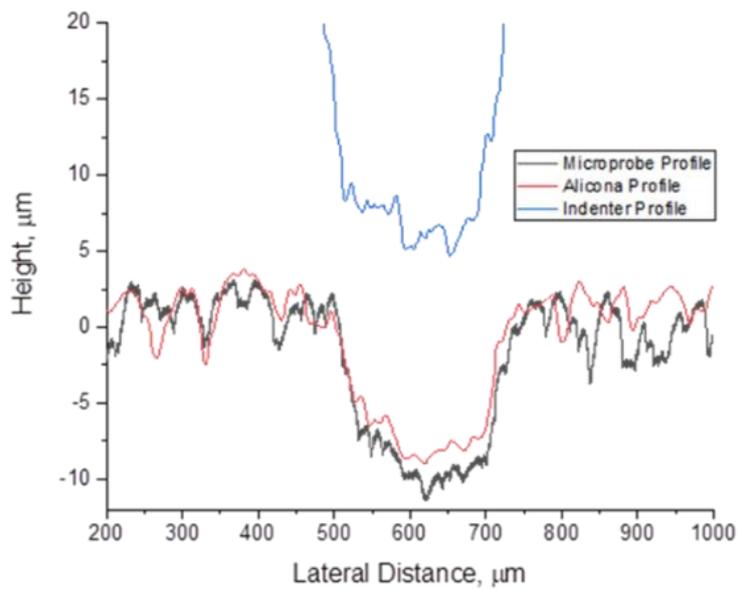
Figure 7, Results from measurements with scratch testing system, a) 3D optical image of scratch stylus, b) image of scratch, c) height map of scratch, d)) comparison between microprobe profile across scratch, Alicona optical height profile, and Alicona profile of scratch indenter.

The surface of the indenter and the scratch itself were examined using an Alicona InfiniteFocus digital microscope. Figures 7a-c show the images of the scratch indenter tip and the scratch. The scratch indenter is quite rough and damaged. This resulted in the rough base of the scratch that was seen in the profiles and the images of the scratch. Figure 7d shows a comparison between profiles of the scratch taken with the microprobe at the end of the experiment, the profile of the scratch extracted from the Alicona height map, and the Alicona height map of the scratch indenter tip. The general form of all of these profiles is very similar.

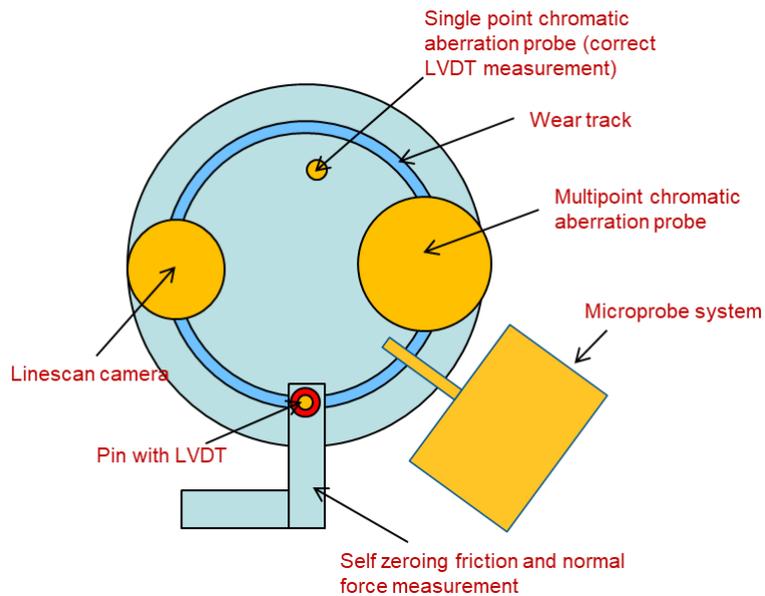
Figure 8, Schematic of NPL integrated pin on disc tribometer

A schematic of the pin-on disc tribometer that was used to explore the utility of the TUBS / PTB microprobe for in situ measurement is shown in Figure 8. The system is fitted with an optical linescan camera which can be used to image the wear track in situ and in real time as it is formed, together with a multipoint chromatic aberration probe that forms in situ real-time non-contact profiles across the wear track [5]. The TUBS/PTB microprobe was mounted on the test system and orientated so that profilometric scans could be made perpendicular to the wear track. The main experiment that was carried out was a rotating scratch test where a Rockwell 200 μm radius diamond indenter was pushed into a rotating disc of steel [6].

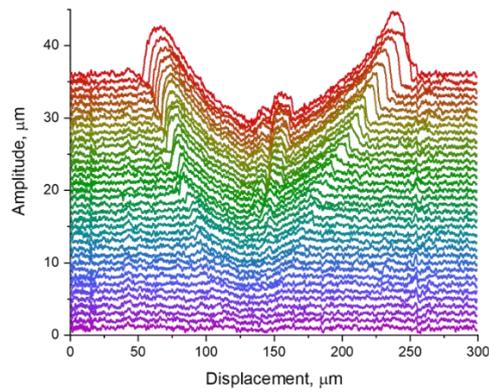
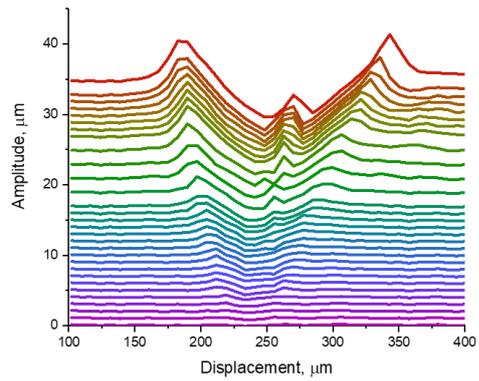
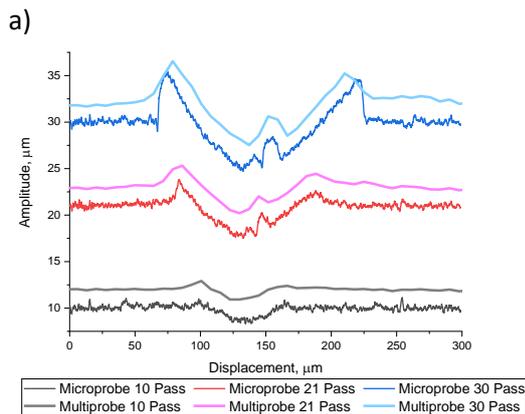
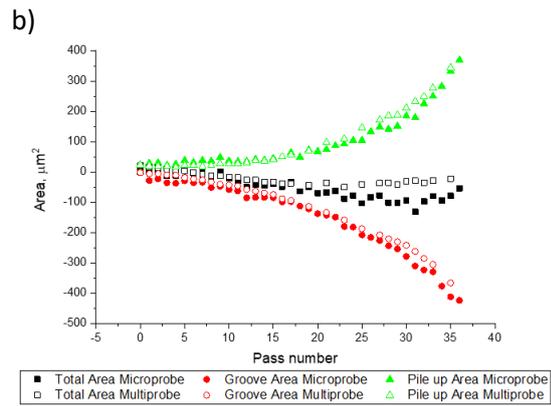
c) d)
 Figure 9, Results from rotating scratch test on steel sample, a) sequence of profiles measured with the microprobe with respect to rotations of disc, b) sequence of profiles measured with chromatic aberration multiprobe with respect to rotations of disc, c) details of comparison between profiles for 3 different number of rotations, d) comparison of quantitative values of damage and their variation with number of rotations for the two different microprobes.

Figure 9 shows the quantitative results from the experiment. Figure 9a shows a waterfall plot of the measurements with the microprobe which clearly show how the depth and width of the groove develops with increasing number of sample rotations. These results are compared with the simultaneous output from the multipoint chromatic aberration probe in Figure 9b. The overall form of the groove is similar, but there is less detail in the chromatic probe output. This is also shown in Figure 9c which shows a direct comparison of the profiles for three rotations of the disc. Again, the form of the profiles is very similar with much more detail in the profiles from the microprobe. This is due to the increased lateral resolution of the microprobe compared to the chromatic aberration probe which is physically limited to 180 measurement points. By integrating the profiles the area of pile up (material raised above the level of the surface outside the scratch), area of the groove (cross-section of area below surface), and area of material lost from surface (groove area – pile-up area). It can be seen that the results obtained from both systems are very similar.

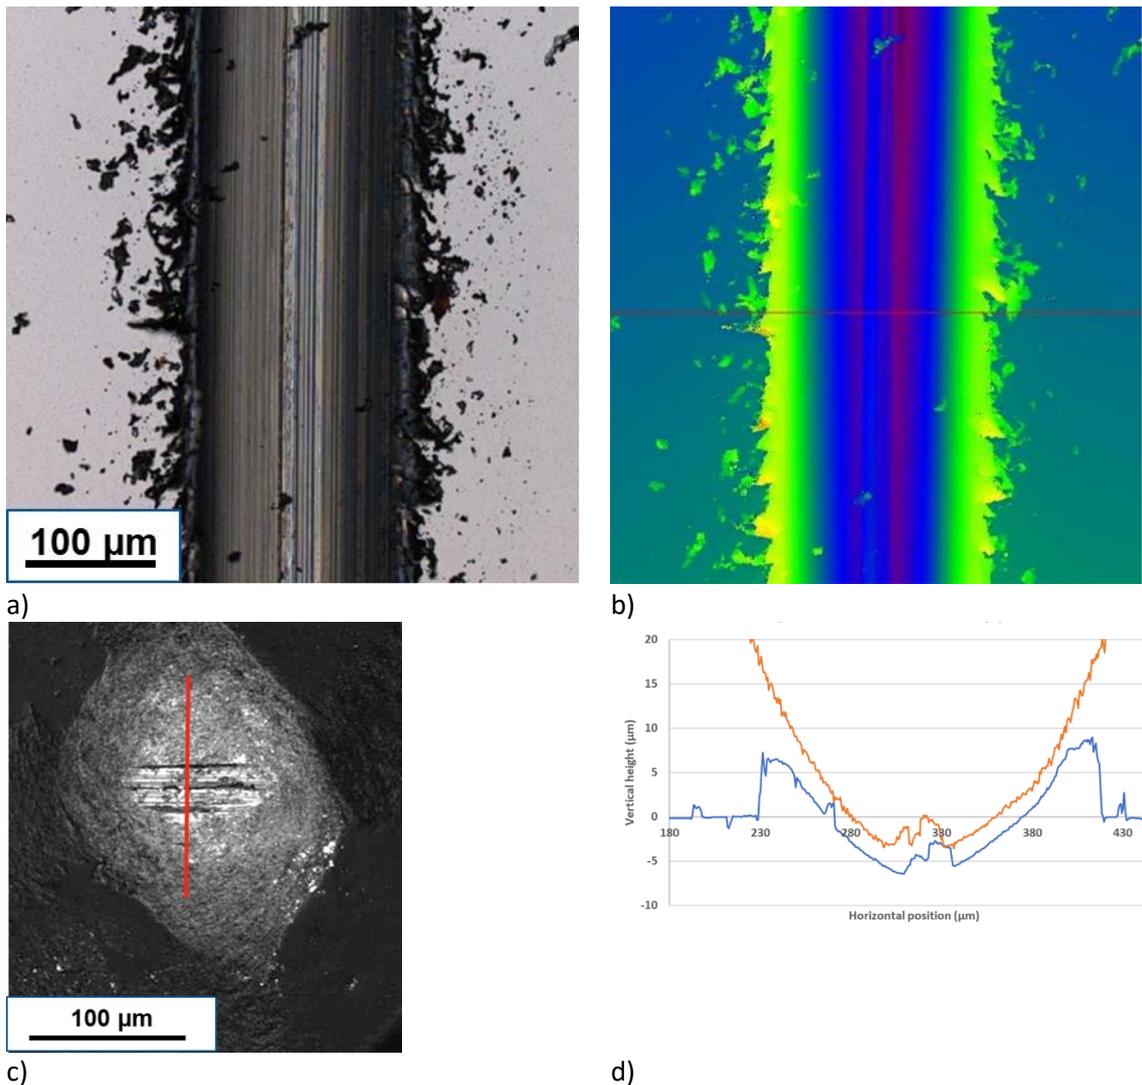
a) optical micrograph of scratch, b) height map of scratch, c) optical image of scratch indenter, d) comparison between confocal profiles taken of scratch indenter (orange) and scratch (blue).

Figure 10 shows the results of a post-test confocal microscopy examination of the groove produced and the indenter used. The reason that the profiles of the groove had a ridge at the base of the groove is seen to be due to the imperfections (grooves) at the tip of the scratch indenter. The profiles obtained in the confocal analysis show good agreement between the form of the groove and the form of the groove indenter.

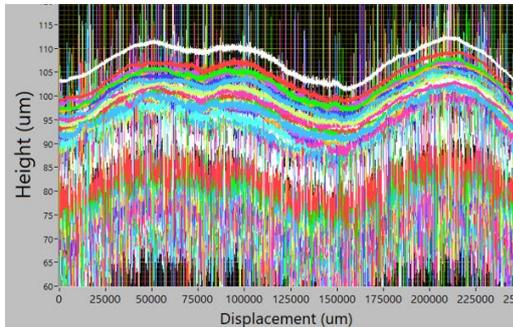
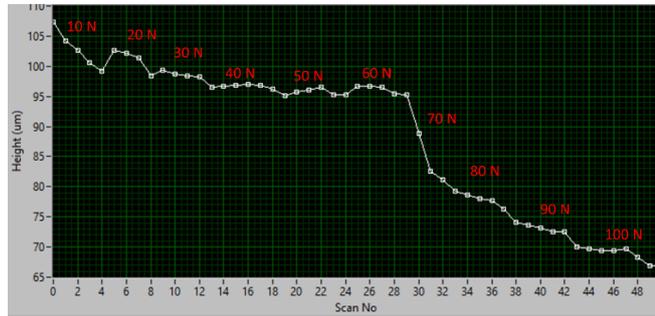
a) b)
 Figure 11, Results from in situ experiment where the microprobe was in contact with the rotating disc throughout the test, a) series of single profiles around wear scar, b) Progression in average depth of wear scar with number of disc rotations.

One experiment was also carried out where the microprobe was orientated so that the microprobe measured the displacement of the wear track in a circumferential direction. A test was carried out where a Si_3N_4 ball was rubbed against a steel surface. The microprobe measured the position of the surface in the wear track continuously as the test was conducted. Figure 11 shows a sequence of profiles measured during the test with the first profile at the top of the stack and later profiles below this (Figure 11a). The general form of the profile is constant and is due to the unevenness of the movement of the surface of the disc with respect to angular position. As the test proceeds the measured roughness of the surface increases as wear processes roughen the surface of the wear track. Taking the average value of one of these profiles as a measure of the overall wear, the progression of these average values gives a quantitative measure of how the wear develops with disc rotations.

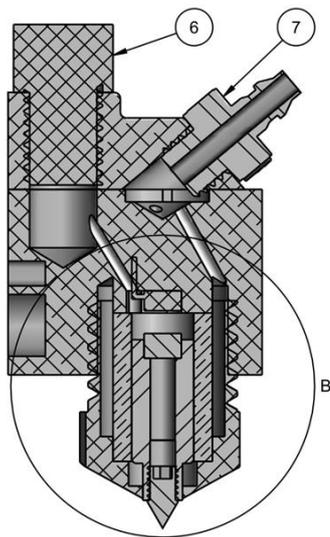
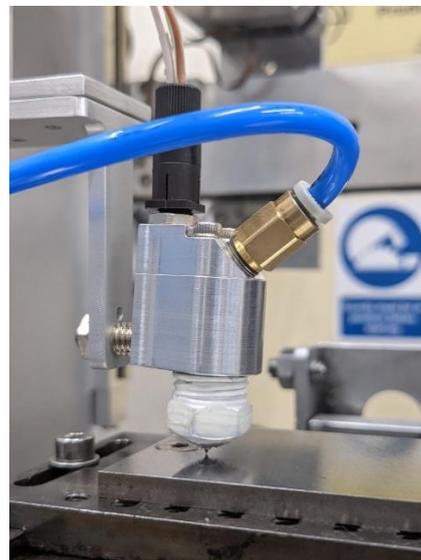
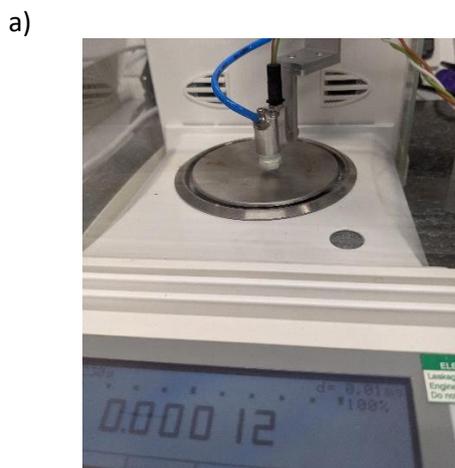
a) b) c)
 Figure 12, University of Southampton profilometer system, a) schematic diagram, b) photograph, c) calibration and optimisation of probe force with an electronic balance

The University of Southampton (UoS) system [10] used a pressurised air bearing to ensure good low friction guidance of the probe as it moves in response to the topography of the surface under measurement (Figure 12). Before use the contact force in the UoS system was calibrated and optimised by measuring the contact force with an electronic balance (Figure 12c).

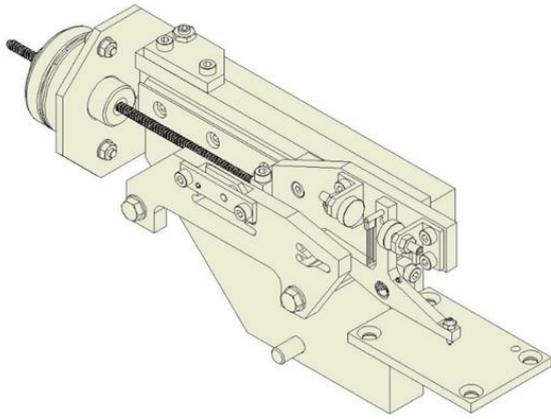
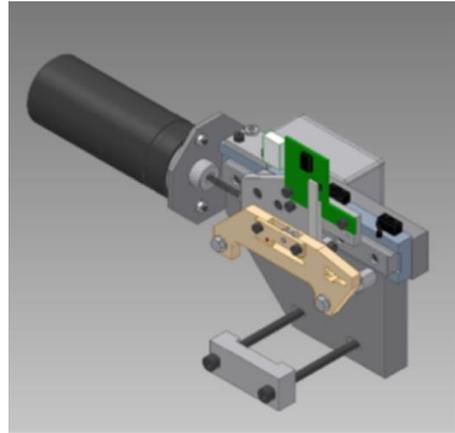
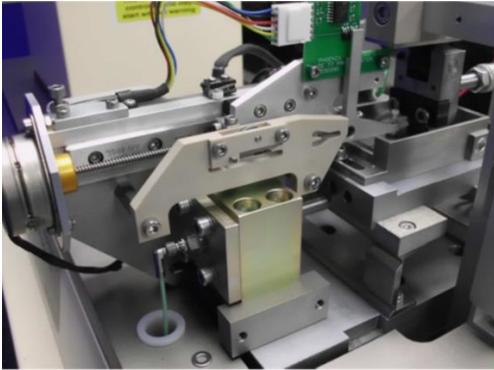
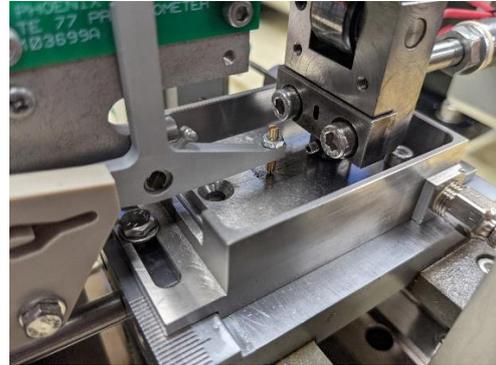
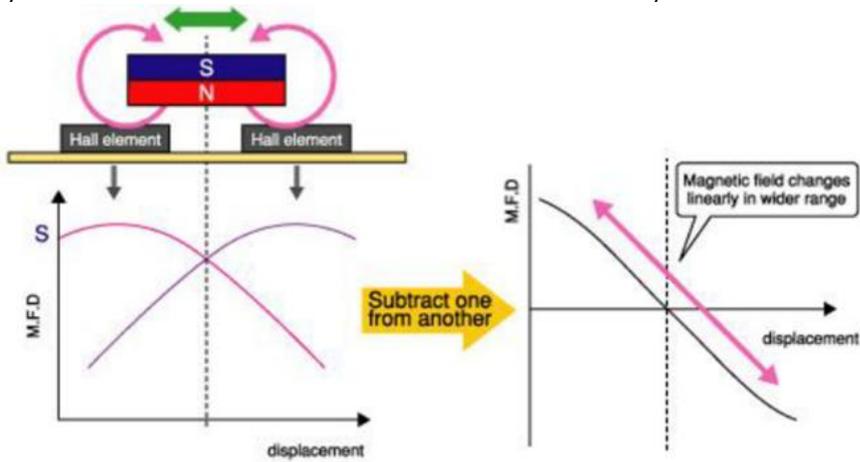
Figure 13, Phoenix Tribology in situ profilometer test system, a) schematic overview, b) 3D model, c) overall image of system, d) close up showing probe making a profile measurement across end of wear track, e) principle of magnetic sensor

The original proof of concept design for the Phoenix Tribology microprobe used a two-axis servo-controlled positioning system [8]. The cost and complexity of this system was considered to render any resulting product not commercially viable. The chosen solution was to use a low-cost stepper driven lead-screw actuator driving a cam actuated lifting, positioning and lowering mechanism.

In the final design of the system that is already sold commercially [9], the stylus is fixed to one arm of a bell-crank cantilever, which is mounted on a flexural bearing. The opposite arm of the cantilever has a pin which engages with the cam track. The flexural bearing is adjusted to give the required normal force on the stylus, when in contact, and the required bias on the pin against the cam track. A vertical arm on the bell-crank provide the means for detecting the motion of the stylus (Figure 13). Originally the displacement of the vertical arm was sensed by a combination of Hall effect sensor and magnets, in “single sensor push-push” configuration. Although this arrangement worked, it was very sensitive to positional setting, did not provide a very large output signal (so has the potential for noise and interference) and was not very linear. The design was revised to incorporate two hall

sensors, mounted side-by-side, so that they mirror each other, with a magnet traversed along the centre line, in slide-by mode (Figure 13e). In the work reported here the Phoenix Tribology Profilometer was tested with the TE77 system at Phoenix Tribology.

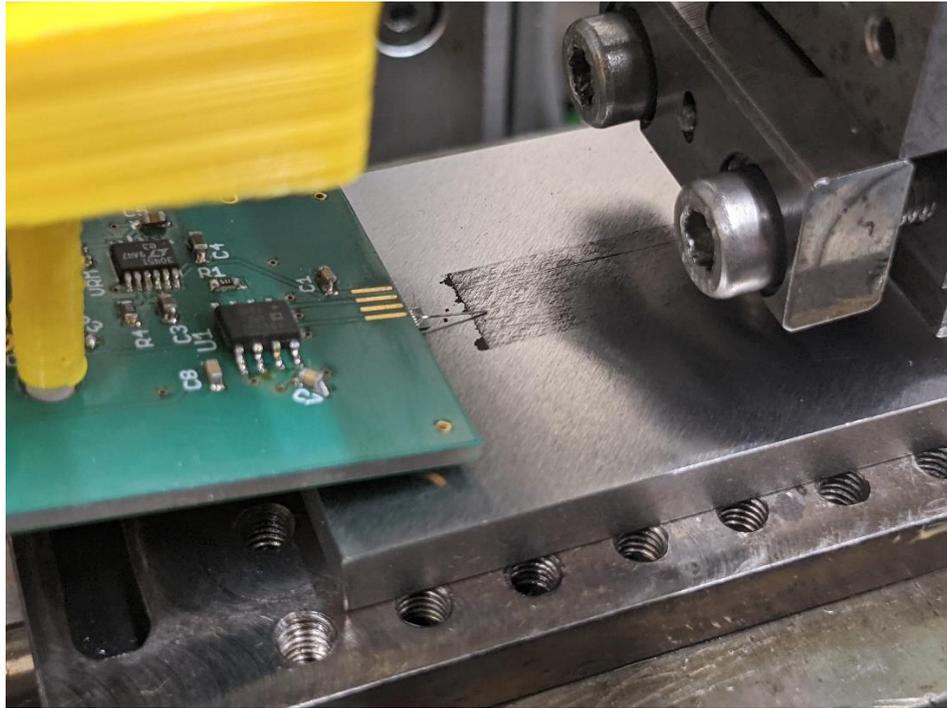
Figure 14, TUBS / PTB microprobe making scan across end of wear track in reciprocating test.

All the measurements were made under identical conditions using a dry sliding wear test using a 10 mm long, 6 mm diameter cylinder made from 52100 reciprocated over 25mm at 2Hz against a flat plate of cast iron. The depth of the cast iron surface was measured after each minute of sliding in the longitudinal direction along the wear track, ensuring that some of the profile extended over the unworn surface at the end of the wear scar to give an internal reference for the profile measurements. Profile measurements were made every minute of the test by stopping the test, carrying out a profile measurement and then restarting the test again until a total of 10 minutes sliding had been completed. A picture of the TUBS / PTB microprobe in operation making a profilometric measurement over the end of a wear track is shown in Figure 14

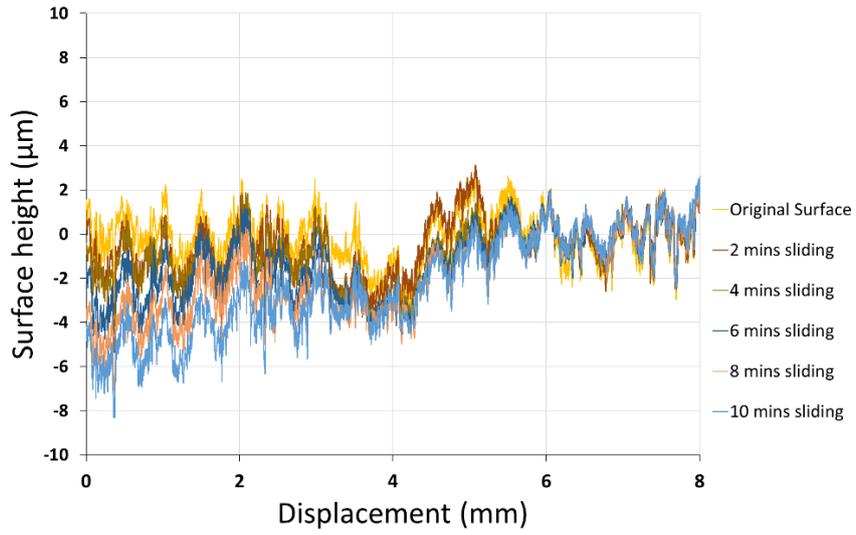
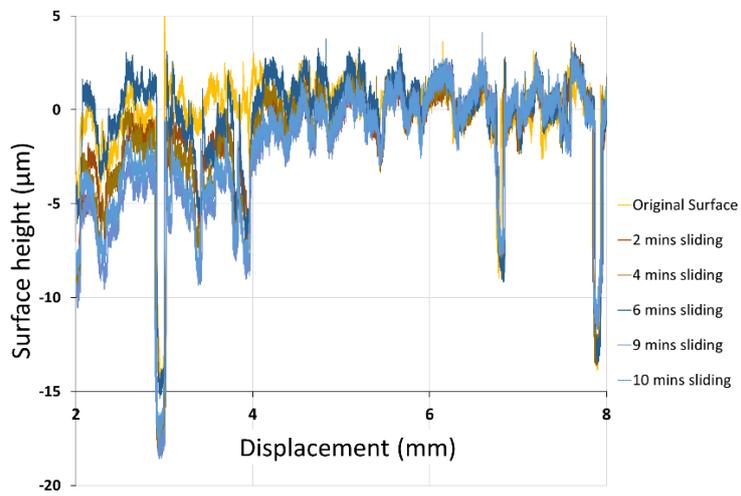
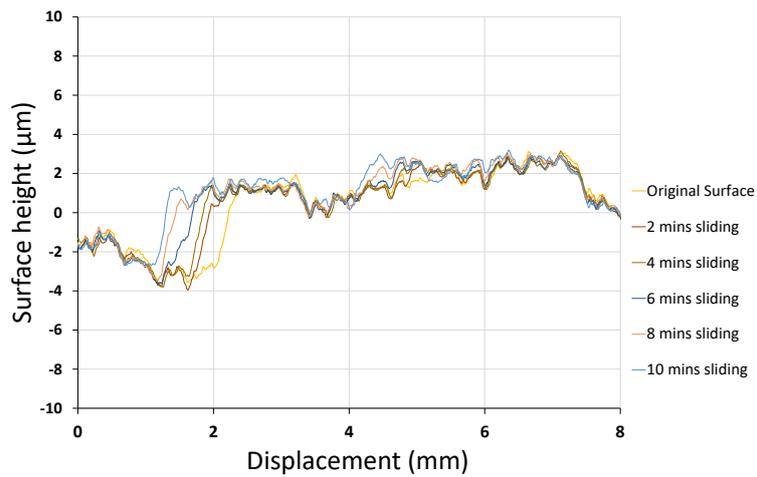
Figure 15, Comparison between profiles obtained on tests carried out under identical conditions for the a) TUBS / PTB microprobe, b) UoS air bearing profilometer, and c) Phoenix Tribology in situ profilometer system

Results from the experiment are shown in Figure 15. All three profile measurement systems gave successful sets of profiles. The TUBS / PTB microprobe and the UoS system gave very similar results with a clear progression in wear as the test progressed. The worn area in these graphs is the left hand of the scan up to a displacement of about 4 mm. The Phoenix Tribology results looks different with no clear progression in profile in the wear scar as the test continues. The appearance of the profiles is different for the Phoenix Tribology profile with much less detail in the profile (The profile seems to be much less “noisy”). This is likely to be due to the differing signal conditioning systems for the different profilometers with the UoS and the TUBS/PTB systems using the same National Instruments hardware and software for acquisition and processing, and the Phoenix Tribology system using proprietary hardware and software. The other difference is that the edge of the wear scar in the Phoenix Tribology profile scans seems to move in towards the centre of the wear scar as the test takes place. This is possibly due to the build up of debris at the end of the wear scar.

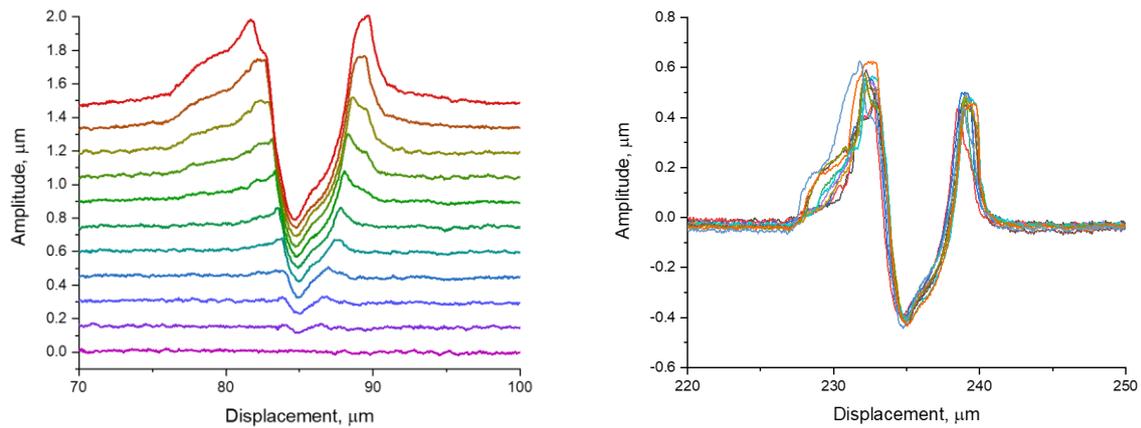
Figure 16, Results of profile measurements made on ex situ microtribometer, a) series of profiles (offset from one another) starting before scratch test has been made and then progressing in 10 MN steps until 100 mN, b) repeated profiles made over final scratch.

A SCSensortech microprobe system was used with a two-axis actuator system with the NPL microtribometer. This microtribometer is designed to be used in situ within an SEM [6] but can additionally be used ex-situ on the laboratory bench. The microprobe was used in an ex-situ experiment where a 1 μm radius diamond indenter was reciprocated across a steel sample. Figure 16 shows profiles that were acquired during this experiment. Figure 14a shows how a scratch profile gets deeper and broader as repeated scratches are carried out along the same scratch path with increasing applied load from 10 mN to 100 mN (the first profile has been acquired before any scratching has taken place). Figure 16b shows multiple profiles acquired repeatedly across the final scratch, showing that the profiles are reasonably consistent and repeatable. The difference in the profile on the left-hand shoulder comes most likely from a slight variation in position for the microprobe scan.

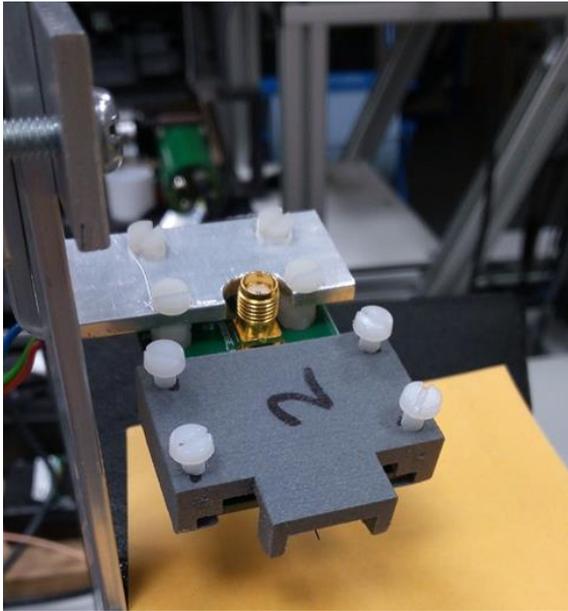
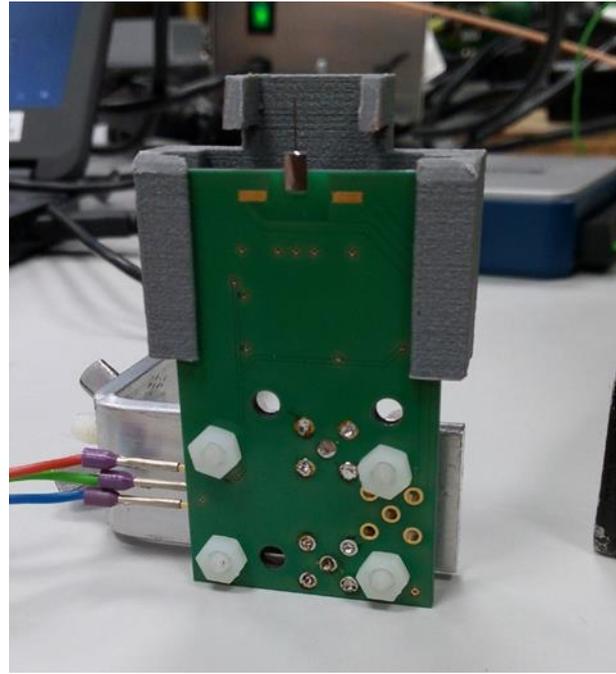
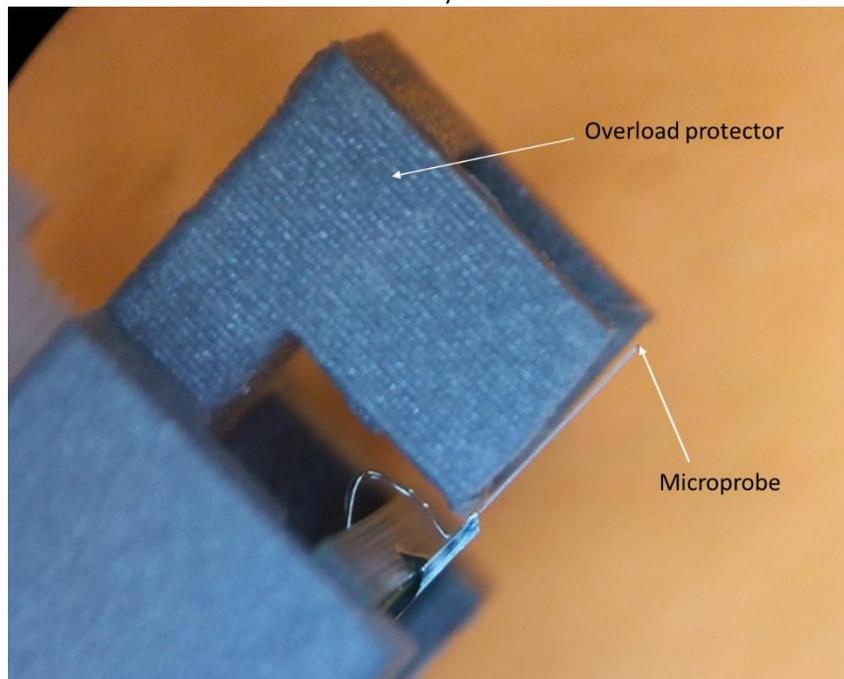
Figure 17, Overload protector fitted to TUBS/ PTB microprobe, a) overall view, b) showing how protector fits around microprobe PCB, c) detail from side.

Initial experiments with the microprobes indicated that they were very fragile and that some protection was necessary to prevent overloading the microprobe cantilever beyond its deflection limit in the event of an unplanned event. Figure 17 shows a simple overload protector that was fitted to the TUBS / PTB microprobe pcb to protect the cantilever. The overload protector was designed

and manufactured so that in the event of a crash where the microprobe moved suddenly against the surface to be measured, the overload protector took up the load and prevented undue deformation to the cantilever, preventing damage.

One drawback of the microprobes is that they are very fragile, so great care is needed to ensure that they are handled carefully. To help to protect the microprobes a simple overload protector was designed and fabricated using polymeric additive manufacturing. This overload protector was practically tested when a sample slipped in a tribological test bringing the microprobe head down sharply onto the opposing sample. The overload protector did its job preventing damage to the microprobe.
